**Lloyds of Abingdon Public Adjusting Firm**

Insured: Sharonna Curnell
Property: 9412 Mulligan Ct.
Jonesboro, GA 30238

Type of Loss: Weather/Water

Lloyds of Abingdon PA Firm, understands that the subject property experienced a recent wind/water-loss event that began from the roof that ultimately allowed a water intrusion that flowed downward resulting in impact to the Attic, Upstairs bedrooms- 1 and 2 as well as the Upstairs Bathroom.

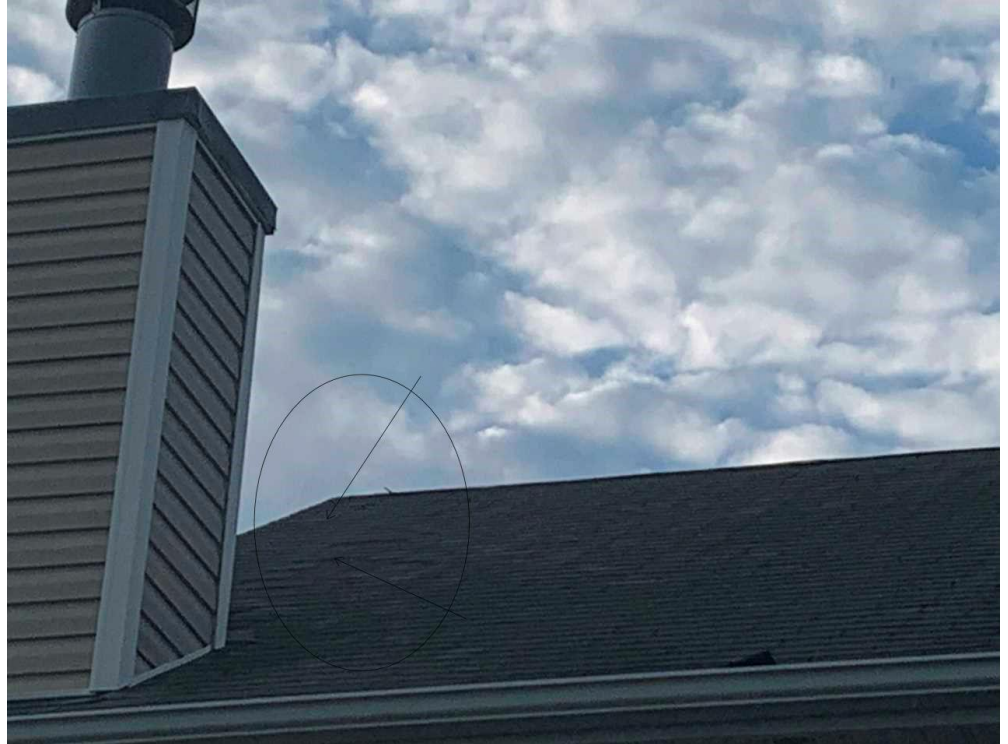
- 5 Exterior - 25-Front Left slope
Date Taken: 8/11/2022

Wind damage.

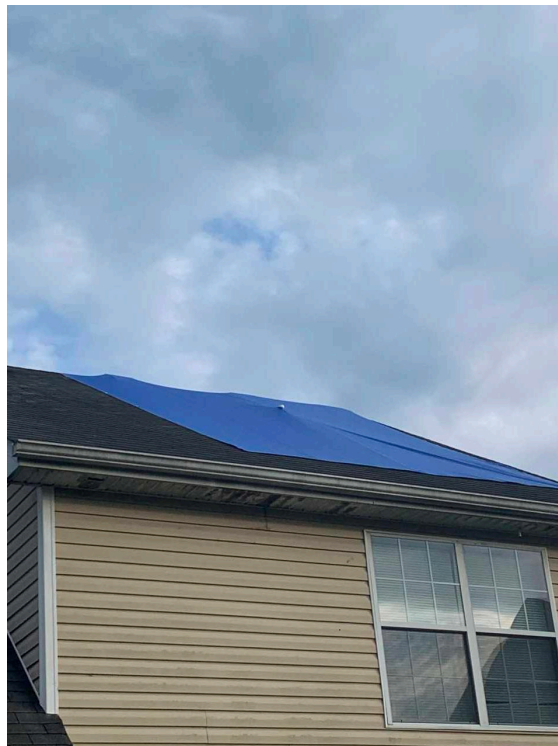
- 8 Exterior - 19-Rear Right slope
Date Taken: 8/11/2022

Wind damage- Property preservation

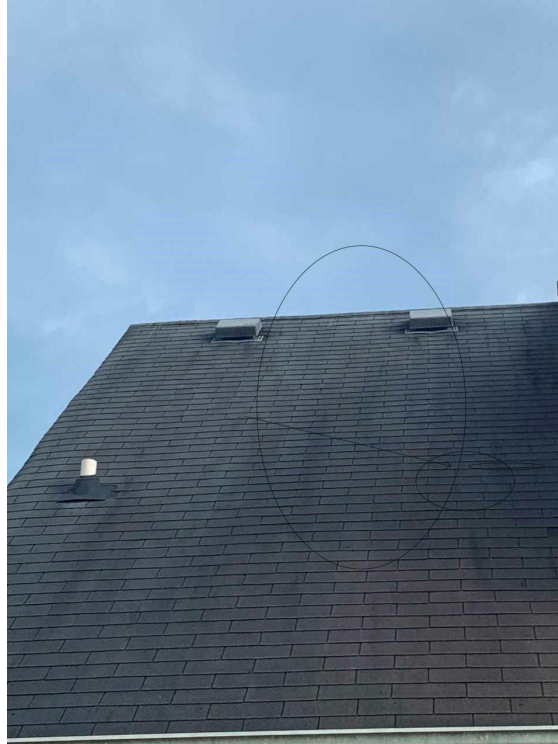
Wind damage

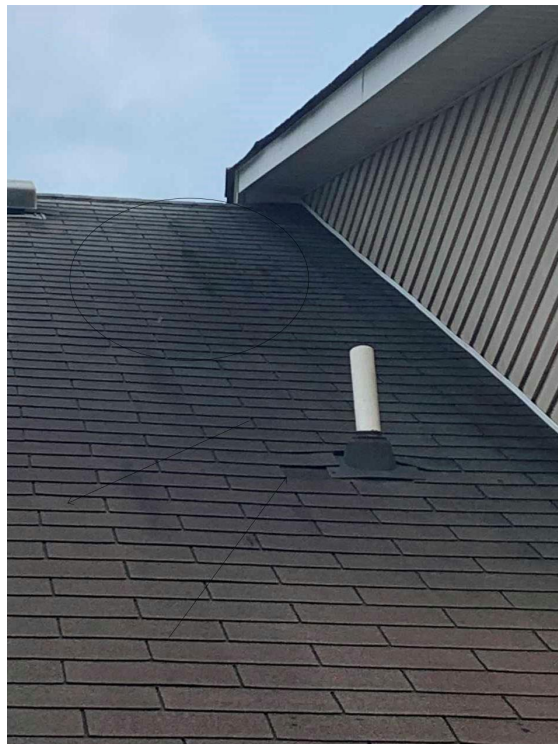
12 Exterior - 22-Rear Left Slope

Wind damage.

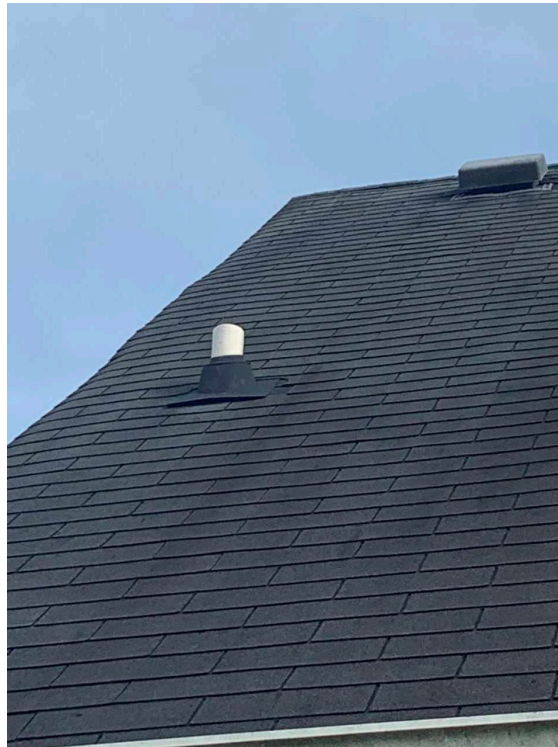
Wind damage

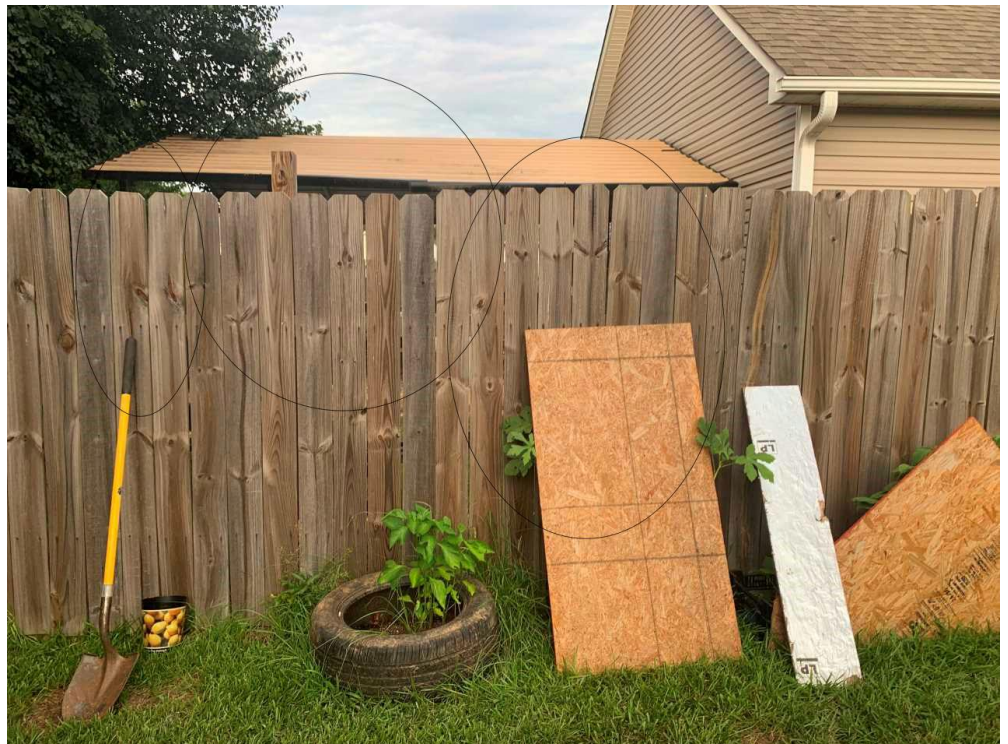
- 18 Exterior - 13-Rear Appertenance
Date Taken: 8/11/2022

Wind damage.

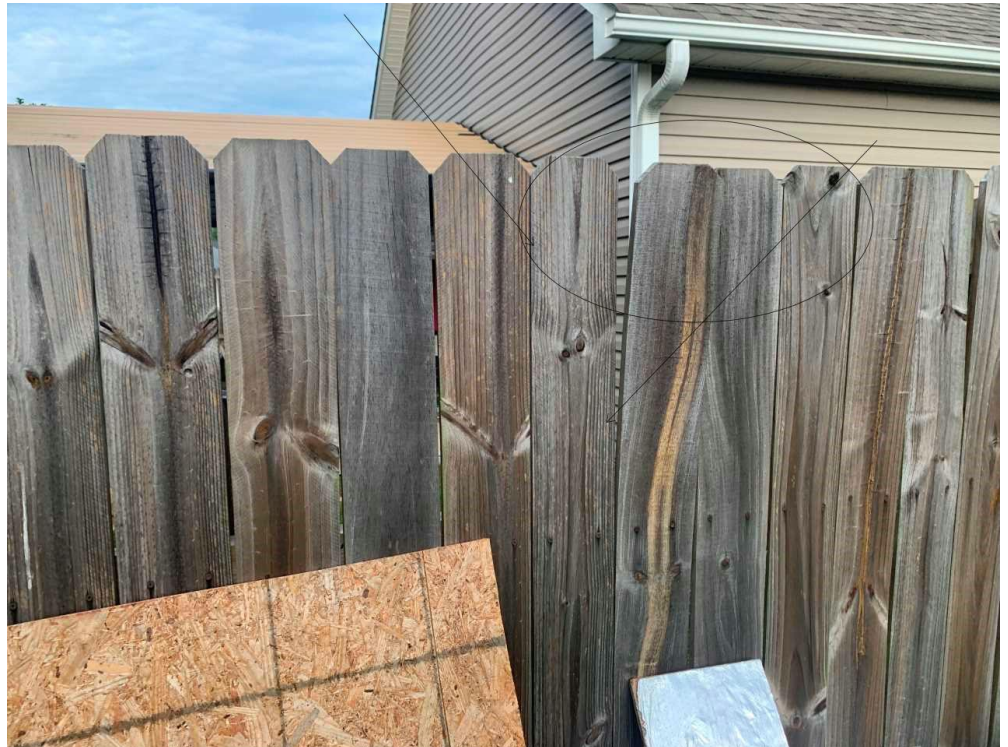
- 19 Exterior - 12-Rear Appertenance
Date Taken: 8/11/2022

Wind damage

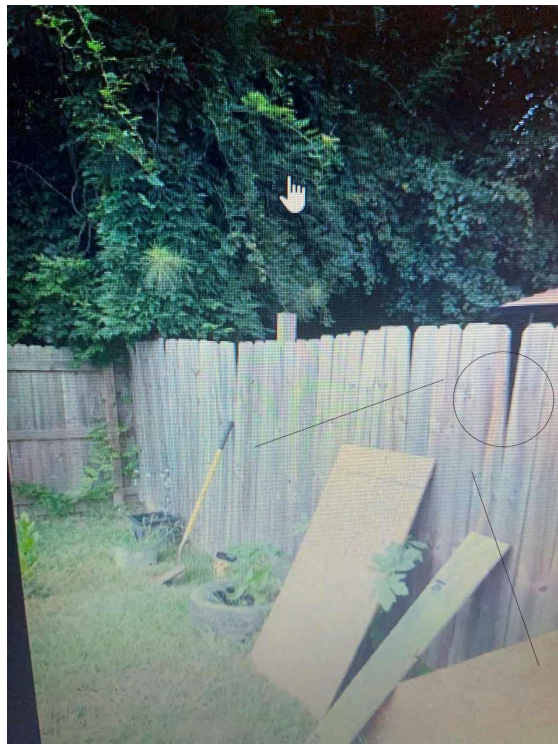
- 20 Exterior - 74-Rear Appertenance
Date Taken: 8/11/2022

Wind damage.

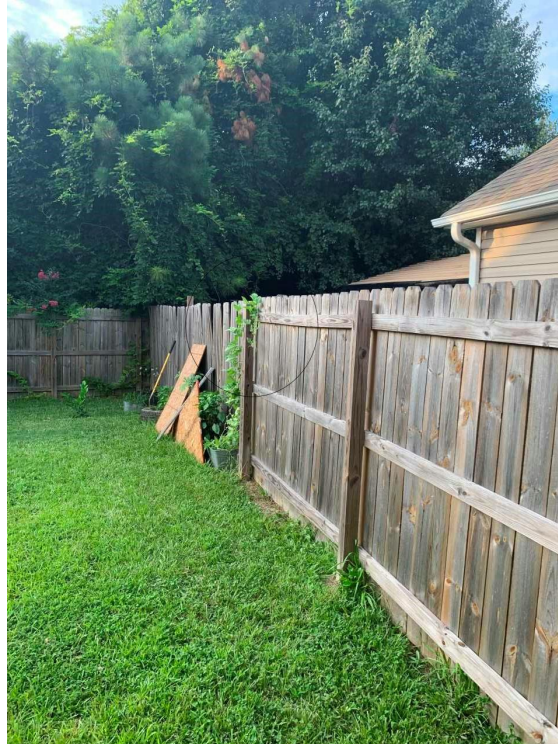
- 21 Exterior - 90-Rear Appertenance
Date Taken: 8/11/2022

Wind damage.

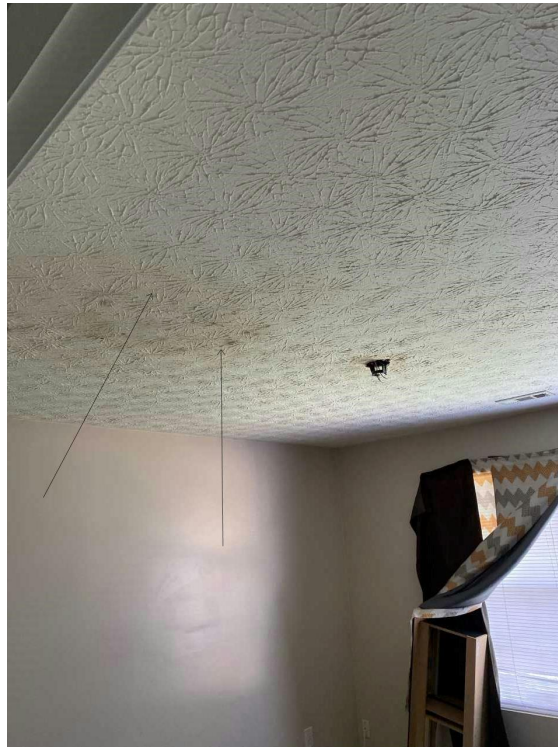
27 95-Upstairs Bdrm 1
Date Taken: 8/11/2022

Water damage

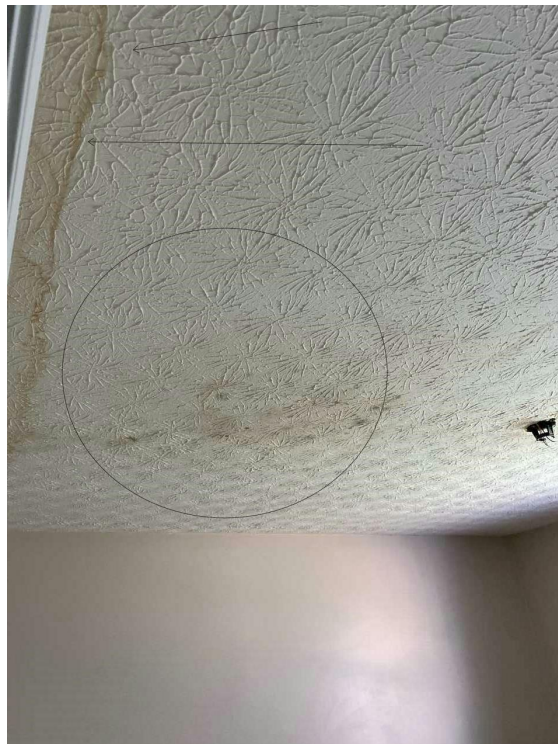
28 94-Upstairs Bdrm 1
Date Taken: 8/11/2022

Water damage

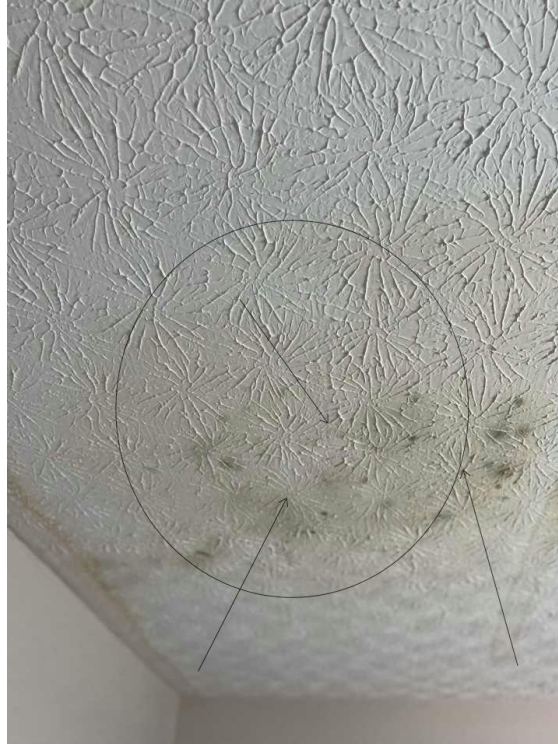
29 96-Upstairs Bdrm 1
Date Taken: 8/11/2022

Water damage

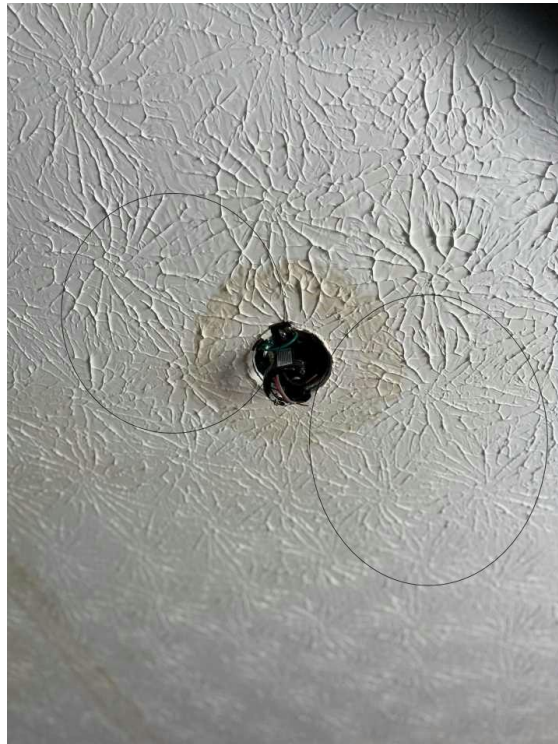
30 97-Upstairs Bdrm 1
Date Taken: 8/11/2022

Water damage

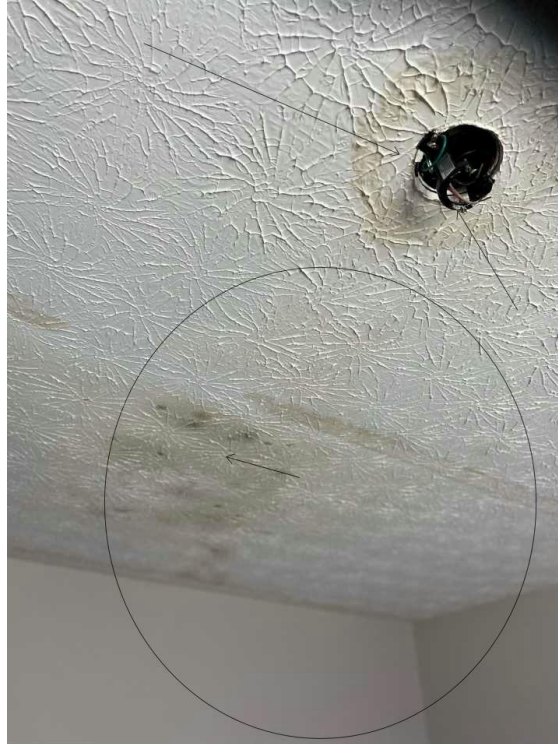
- 31 98-Upstairs Bdrm 1
Date Taken: 8/11/2022

Water damage

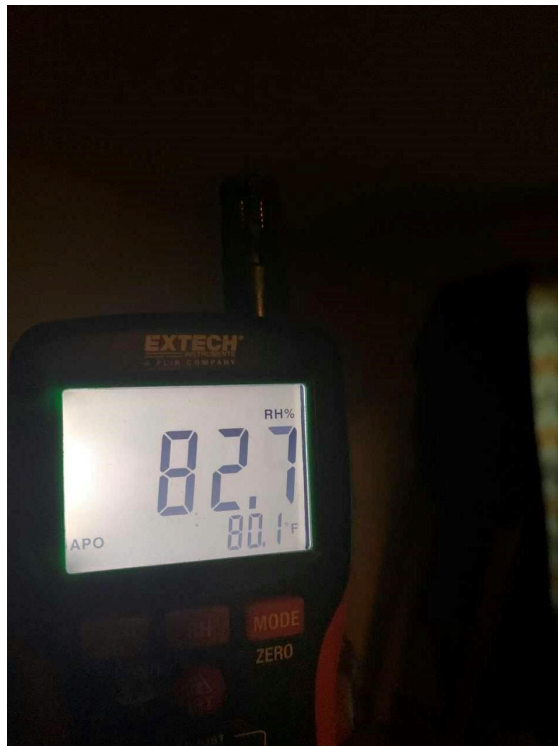
- 32 1-Upstairs Bdrm 1
Date Taken: 8/11/2022

Pre-mitigation. Highly elevated moisture readings signifying ambient air. It is nearly saturated with moisture. Secondary damages occur at 60 RH and higher (IICRC S520 Standard of care). Dehumidification is Urgently needed.

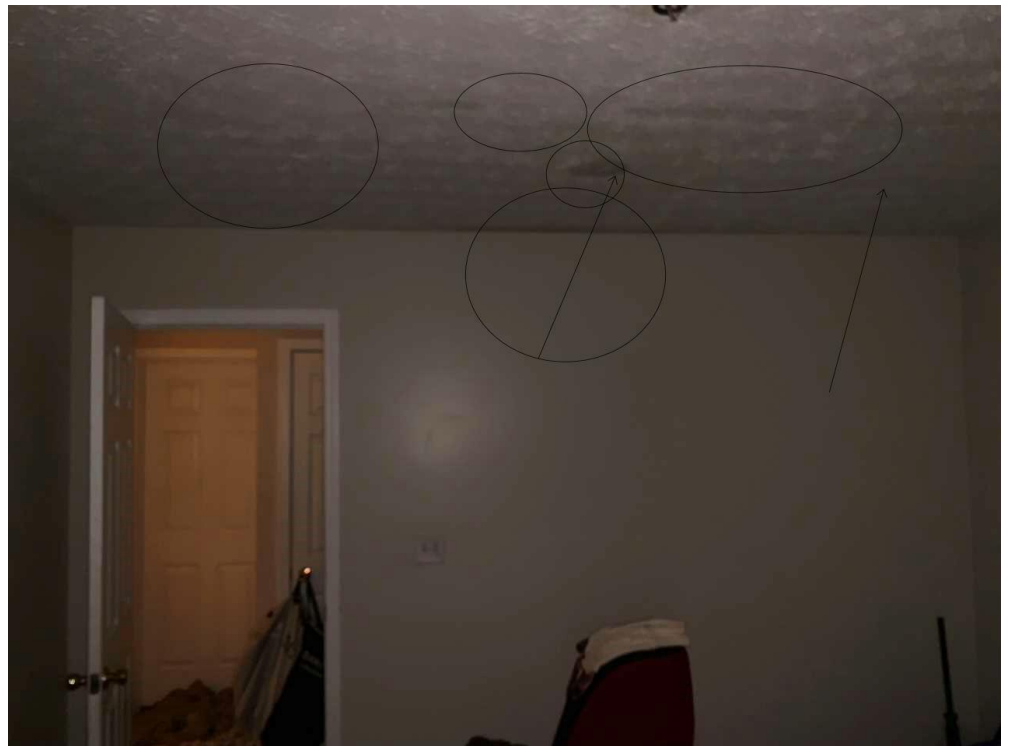
- 34 33-Upstairs Bdrm 1
Date Taken: 8/11/2022

Interior water damage.

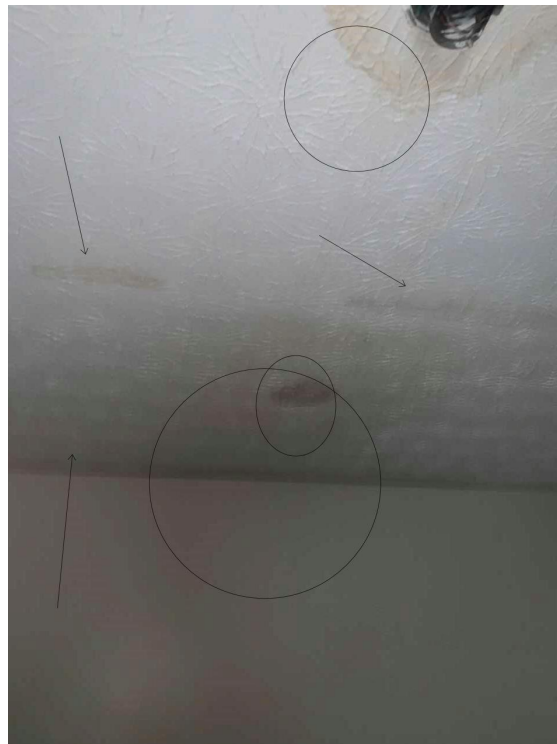
36 36-Upstairs Bdrm 1
Date Taken: 8/11/2022

Interior water damage.

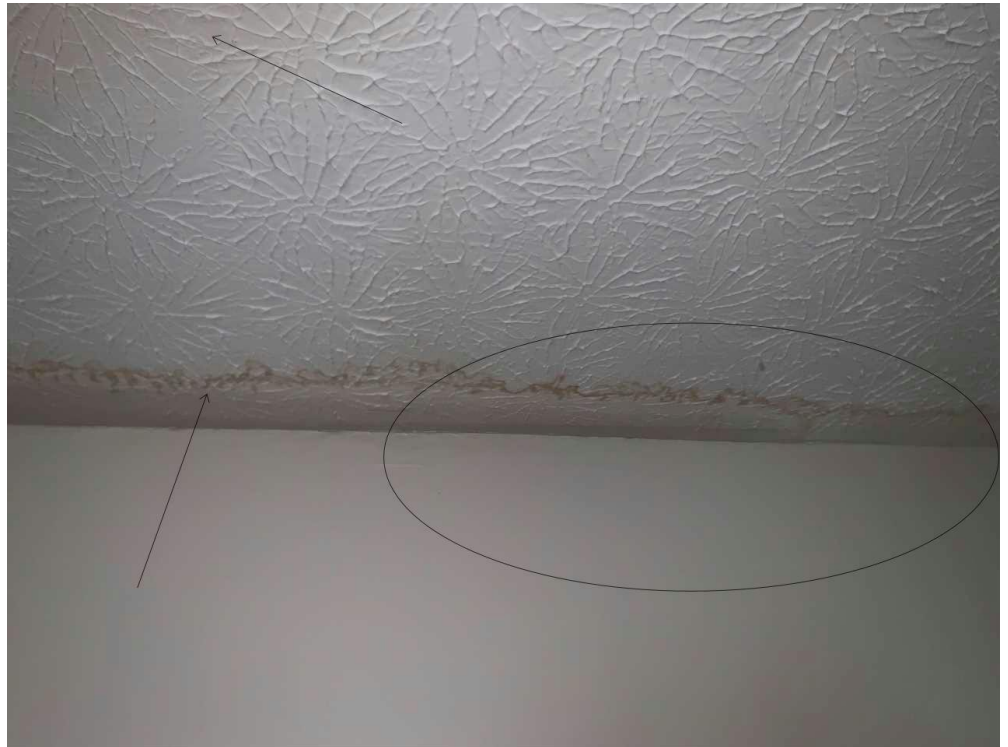
37 37-Upstairs Bdrm 1
Date Taken: 8/11/2022

Interior water damage.

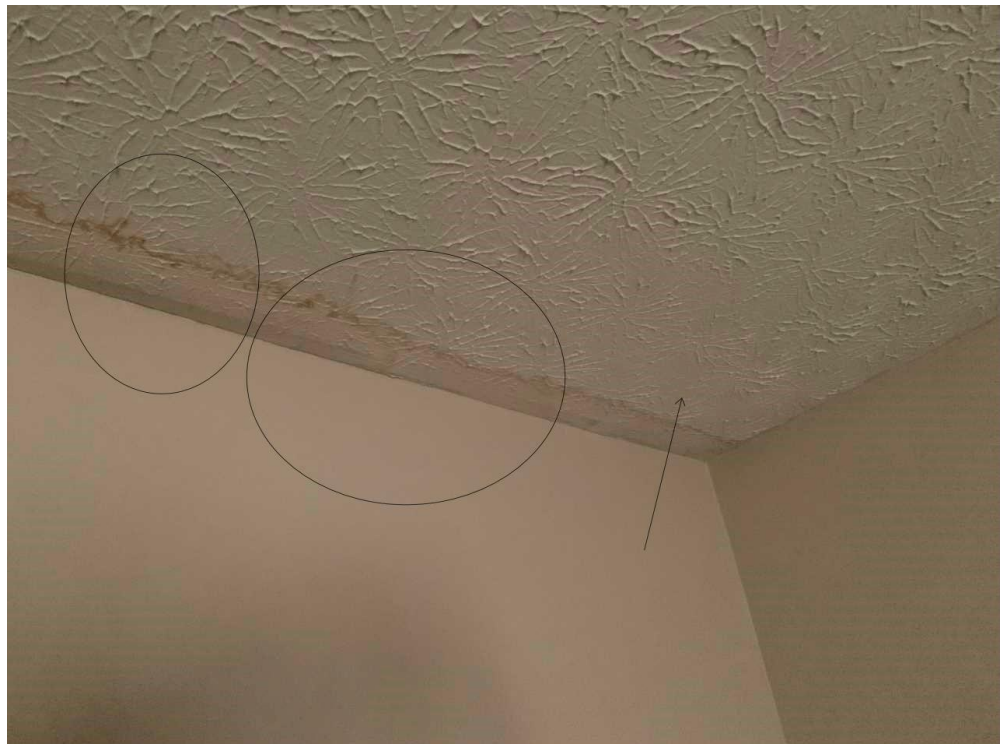
38 38-Upstairs Bdrm 1
Date Taken: 8/11/2022

Interior water damage. Upstairs hall
bath is on the other side of wall.

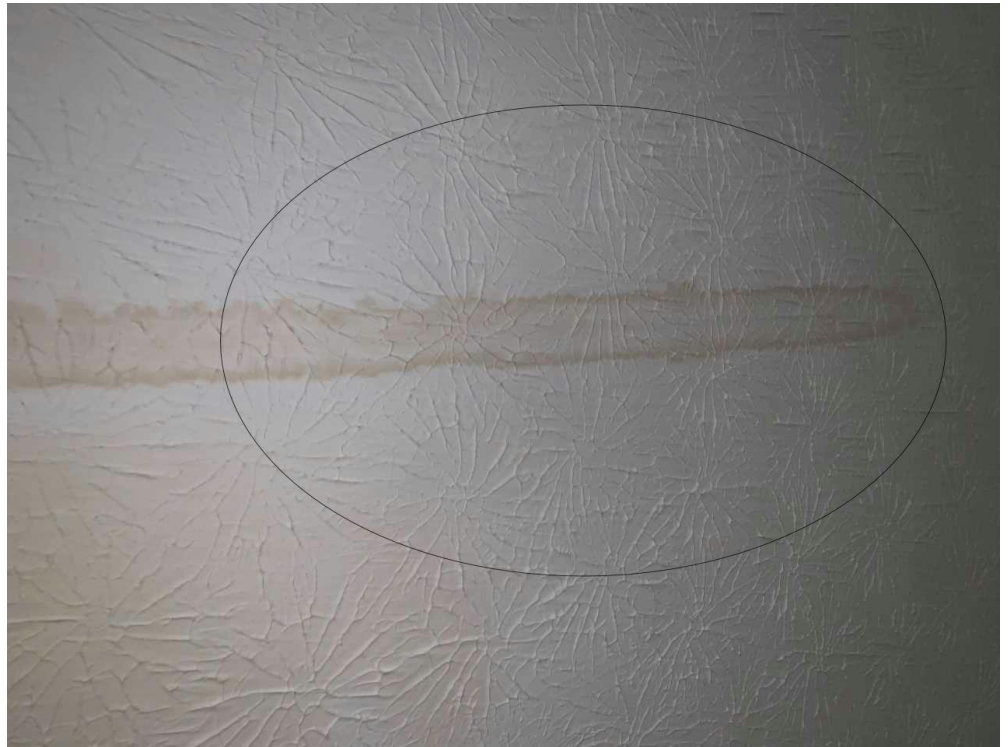
39 39-Upstairs Bdrm 1
Date Taken: 8/11/2022

Interior water damage.

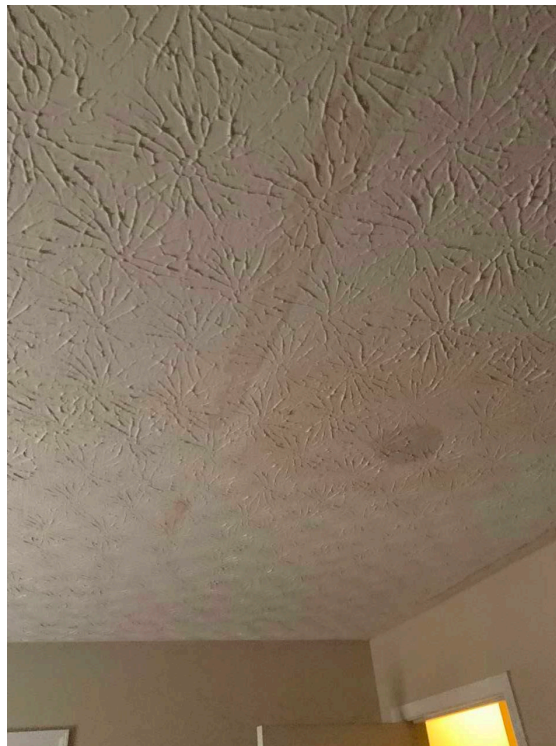
40 40-Upstairs Bdrm 1
Date Taken: 8/11/2022

Interior water damage.

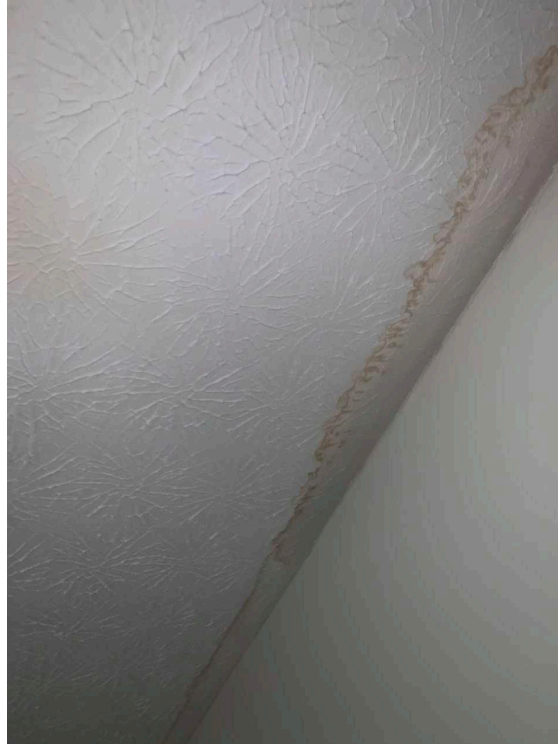
41 41-Upstairs Bdrm 1
Date Taken: 8/11/2022

Interior water damage.

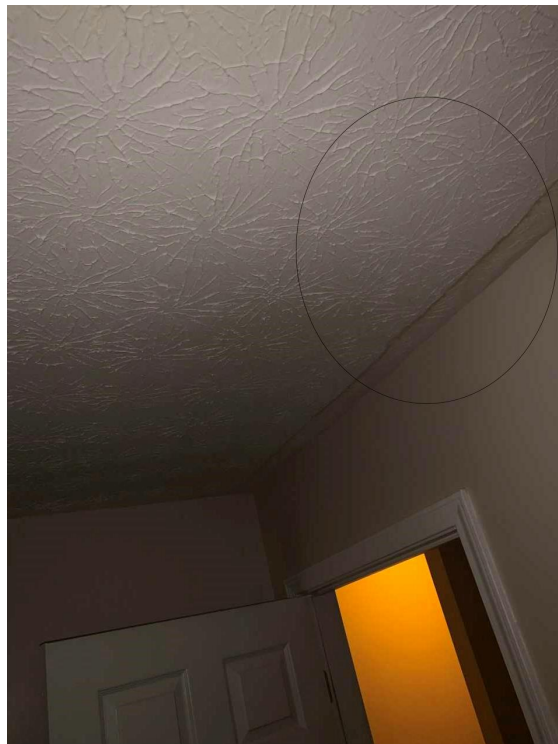
42 42-Upstairs Bdrm 1
Date Taken: 8/11/2022

Interior water damage.

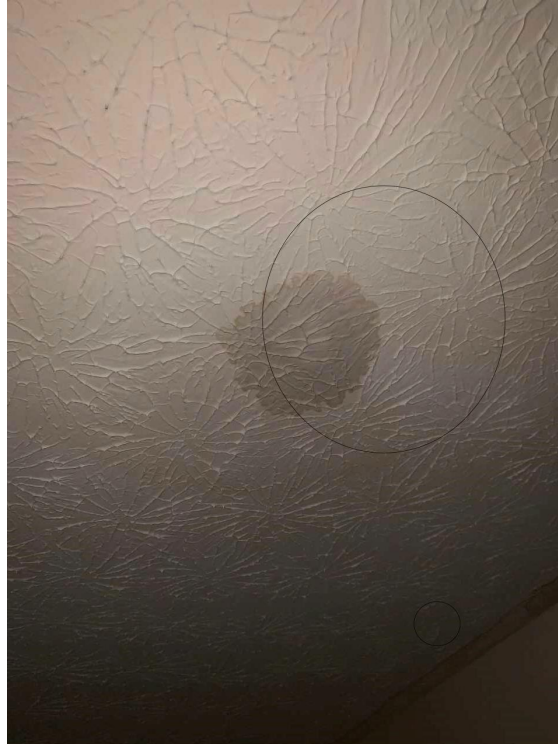
- 43 43-Upstairs Bdrm 1
Date Taken: 8/11/2022

Interior water damage.

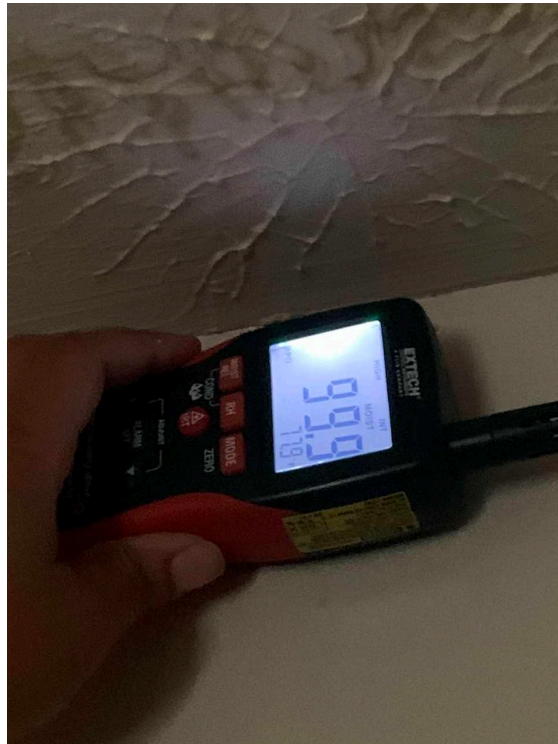
- 44 61-Upstairs Bdrm 1
Date Taken: 8/11/2022

Pre- Mitigation/Remediation.
Saturation of MC (moisture content)
of surface materials (drywall) framing
members, etc... Secondary damages
may be present due to bound, high
moisture.

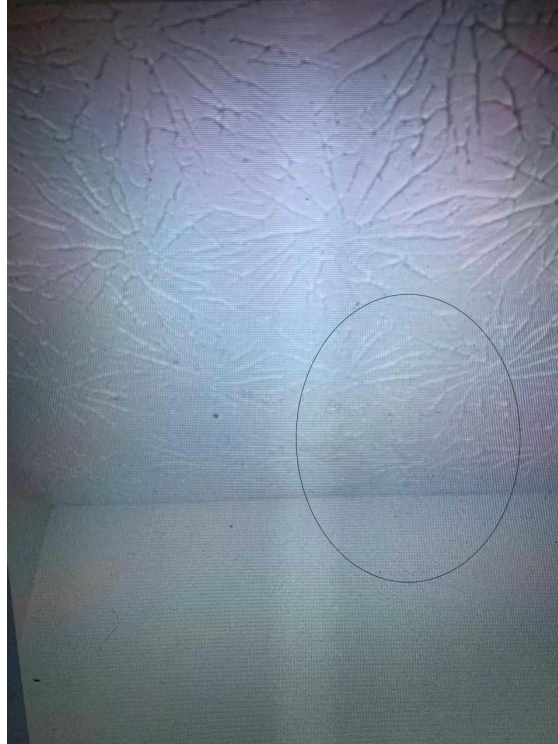
- 45 65-Upstairs Bdrm 2
Date Taken: 8/11/2022

Interior water damage (ceiling).

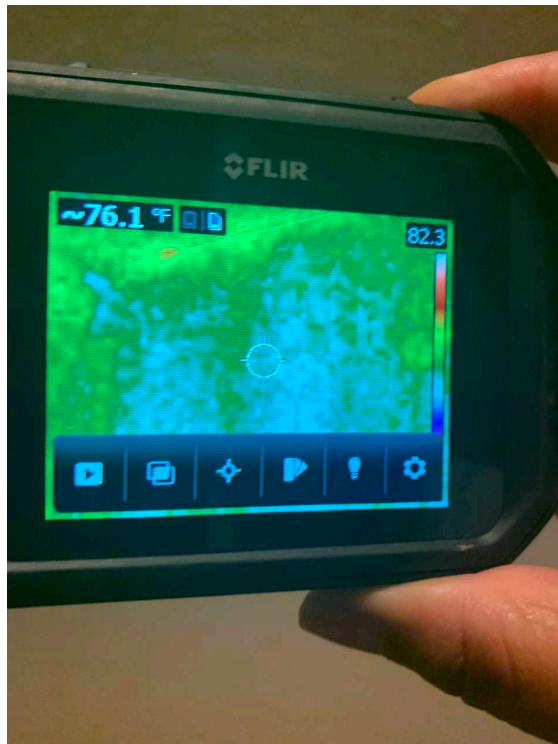
- 46 87-Upstairs Bdrm 1
Date Taken: 8/11/2022

Thermography: Bound moisture trapped within closed ceiling and wall cavities.

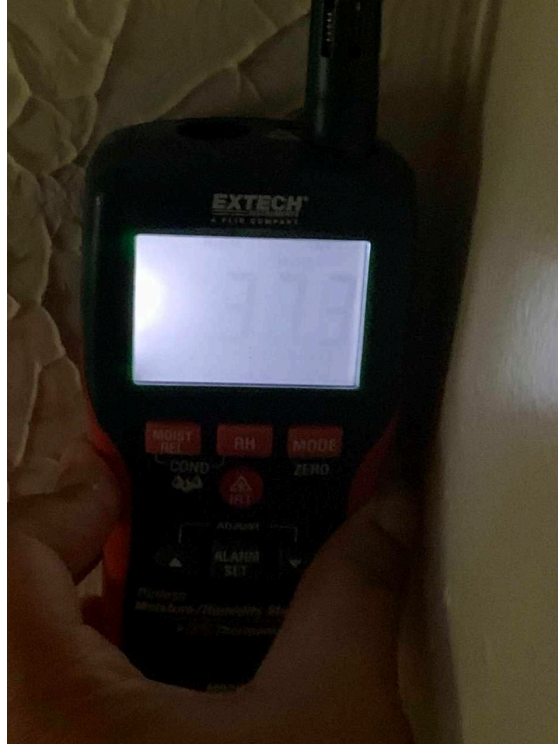
- 47 62-Upstairs Bdrm 1
Date Taken: 8/11/2022

Pre- Mitigation/Remediation.
Saturation of MC (moisture content)
of surface materials (drywall) framing
members, etc... Secondary damages
may be present due to bound, high
moisture.

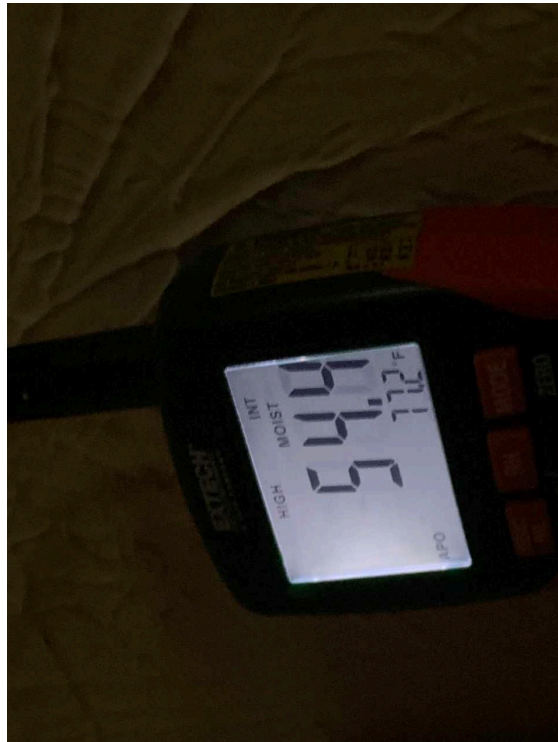
- 48 86-Upstairs Bdrm 1
Date Taken: 8/11/2022

Pre- Mitigation/Remediation.
Saturation of MC (moisture content)
of surface materials (drywall) framing
members, etc... Secondary damages
may be present due to bound, high
moisture.

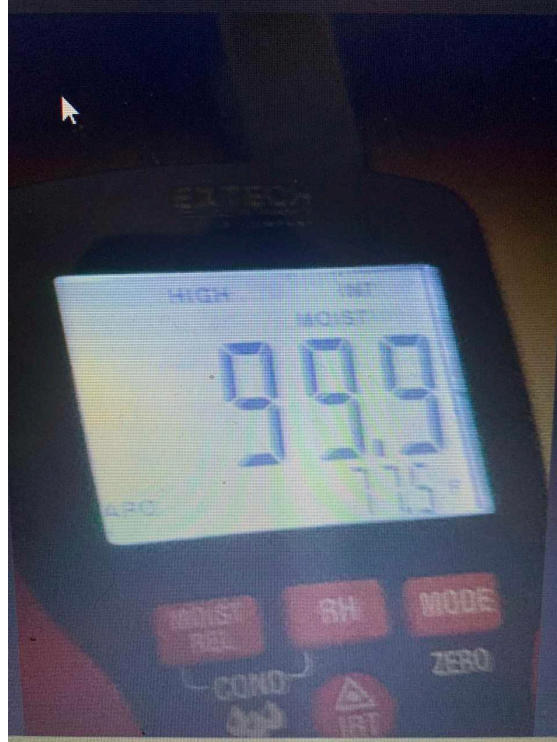
- 49 63-Upstairs Bdrm 1
Date Taken: 8/11/2022

Pre- Mitigation/Remediation.
Saturation of MC (moisture content)
of surface materials (drywall) framing
members, etc... Secondary damages
may be present due to bound, high
moisture.

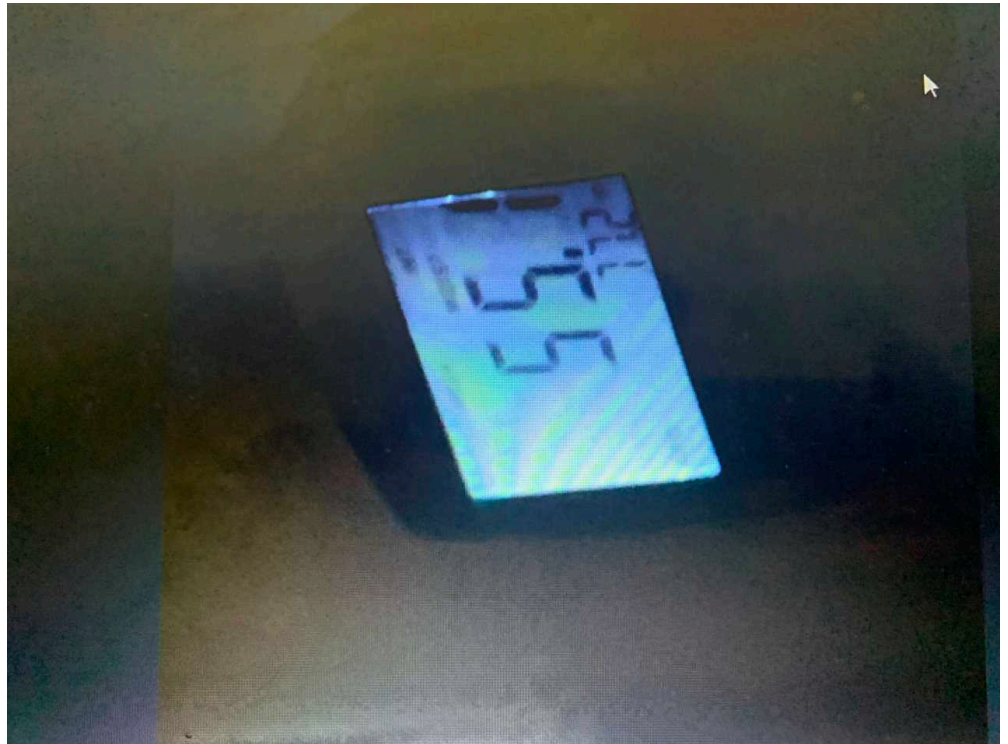
- 50 3-Upstairs Bdrm 1
Date Taken: 8/11/2022

Pre- Mitigation/Remediation.
Saturation of MC (moisture content)
of surface materials (drywall) framing
members, etc... Secondary damages
may be present due to bound, high
moisture.

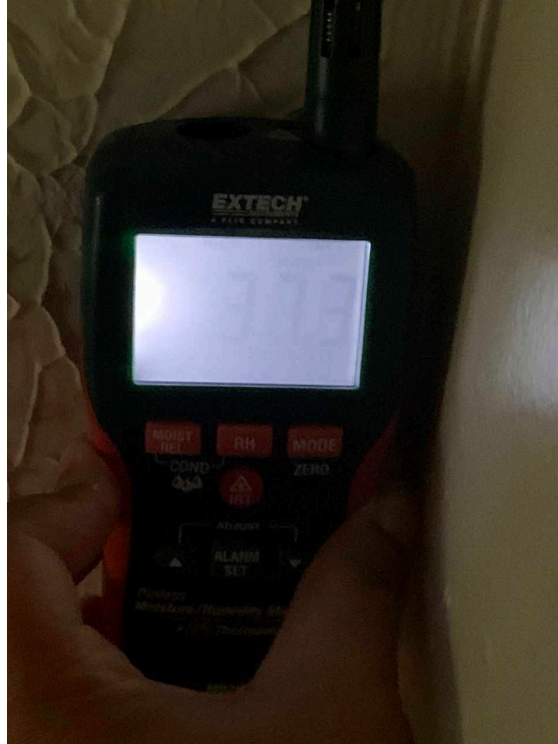
- 51 5-Upstairs Bdrm 1
Date Taken: 8/11/2022

Pre- Mitigation/Remediation.
Saturation of MC (moisture content)
of surface materials (drywall) framing
members, etc... Secondary damages
may be present due to bound, high
moisture.

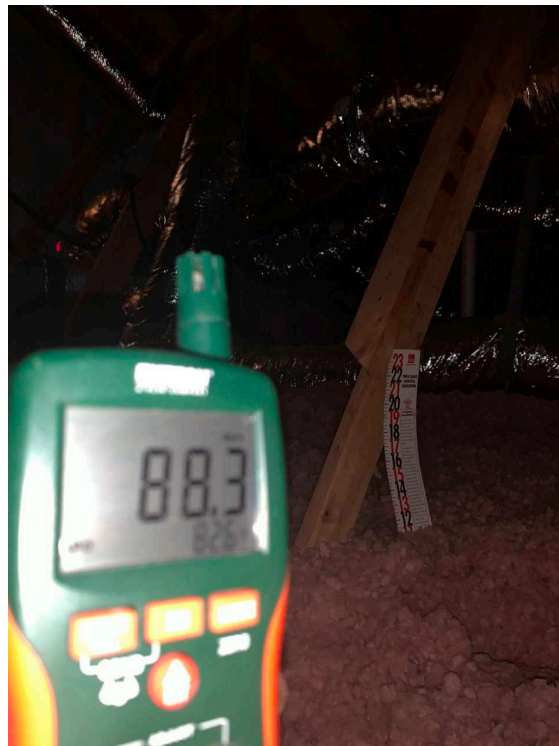
54 53-Attic

Pre-mitigation. Highly elevated moisture readings signifying ambient air. It is nearly saturated with moisture. Secondary damages occur at 60 RH and higher (IICRC S520 Standard of care). Dehumidification is Urgently needed.

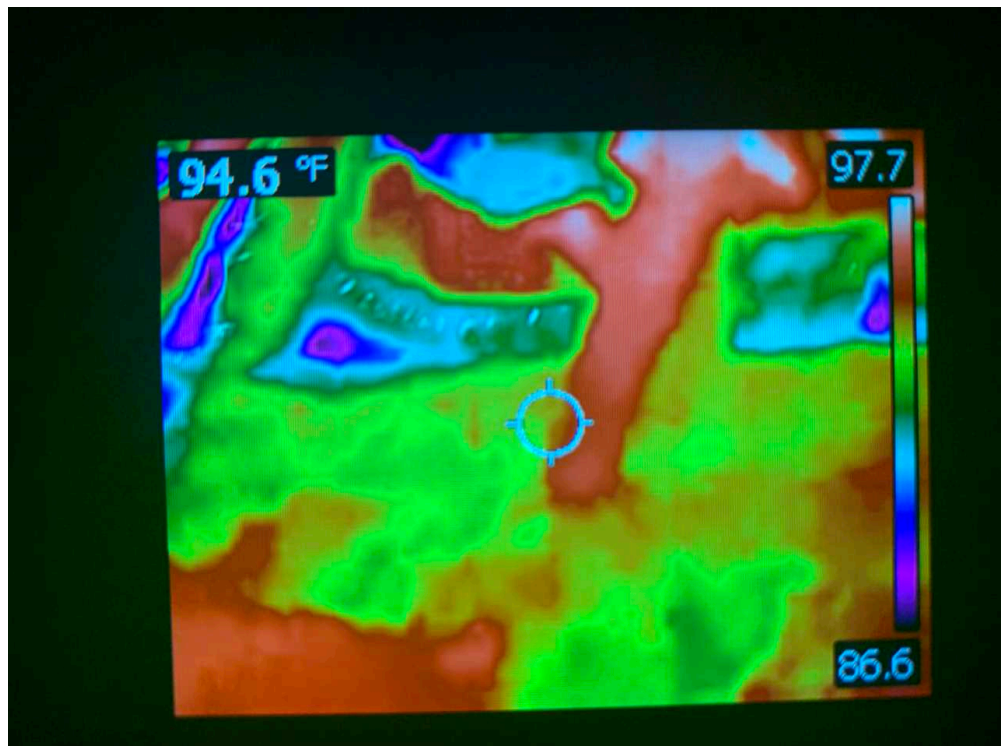
56 46-Attic

Thermography: Moisture trapped
within attic cellulose insulation.

32. Tear out and bag wet insulation	178.75 SF		3.11	0.00	0.97	0.00	556.88
To tear out and bag cellulose insulation from attic above, damaged by water from compromised roof.

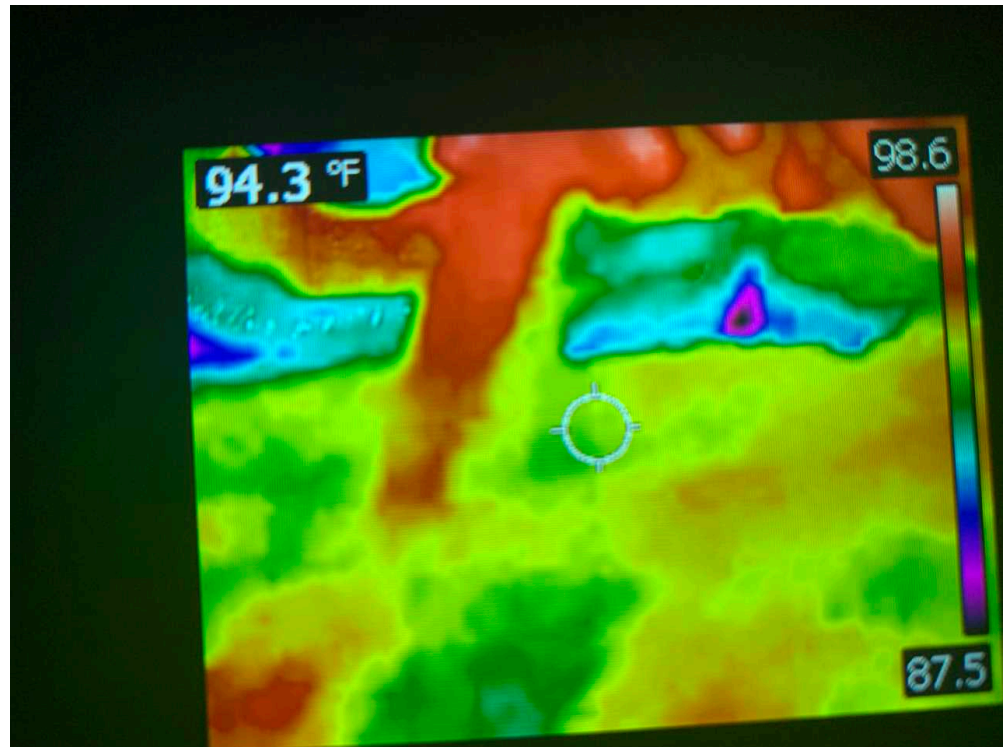
Thermography: Moisture trapped
within attic cellulose insulation.

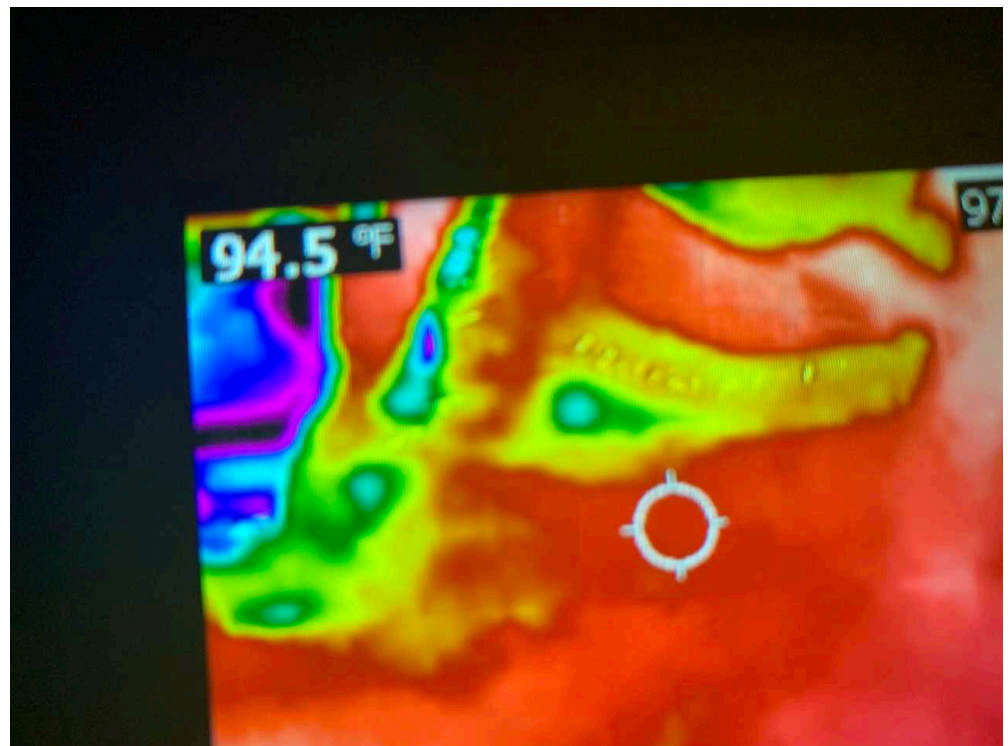
58 48-Attic

Thermography: Moisture trapped
within attic cellulose insulation.

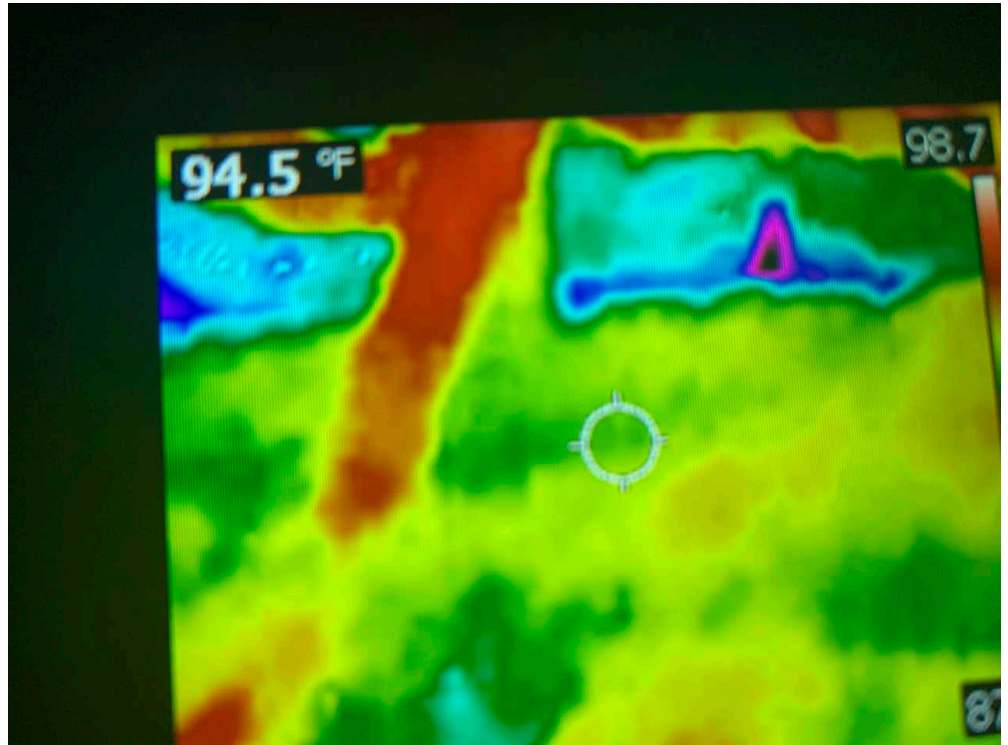
Thermography: Moisture trapped
within attic cellulose insulation.

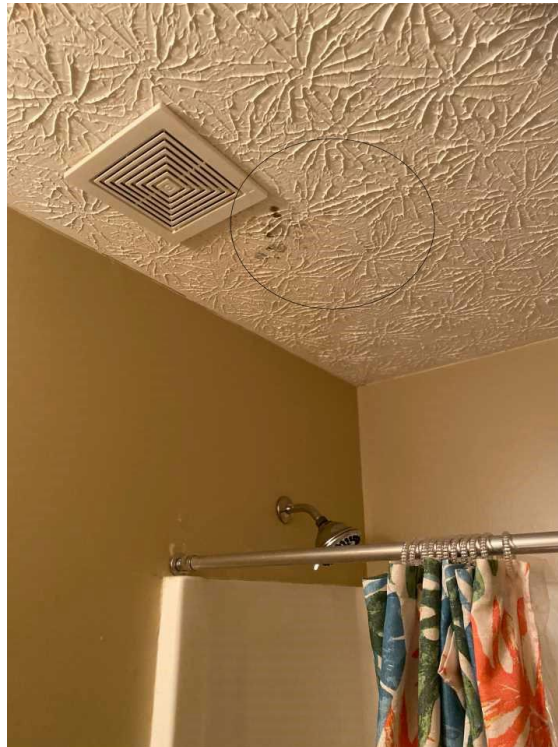
63 93-Upstairs Hall Bath
Date Taken: 8/11/2022

Water damage on ceiling.

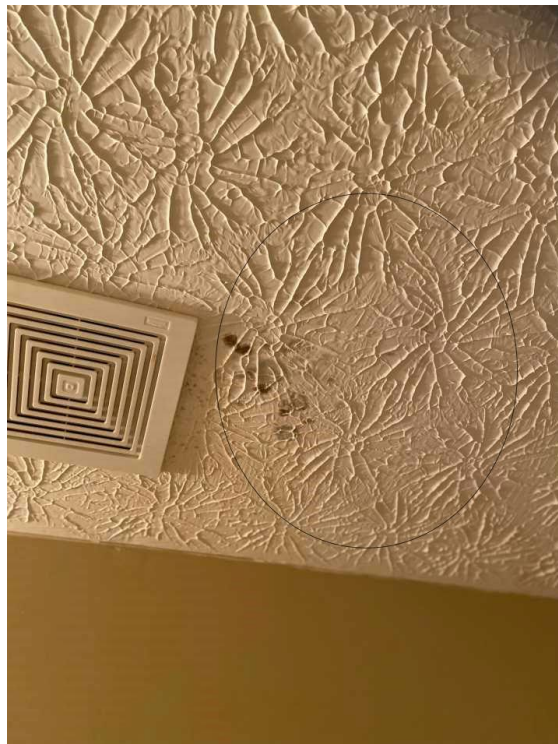
64 92-Upstairs Hall Bath
Date Taken: 8/11/2022

Water damage on ceiling.

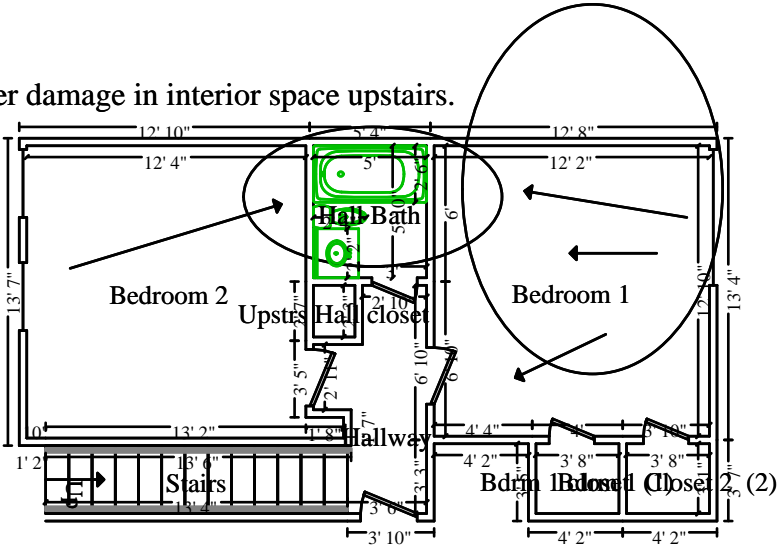
Water damage in interior space upstairs.
